**Plainfield Public Library**

## **Facility Infrastructure Assessment**

**KJWW#11.0712.00**

**February 9, 2012**

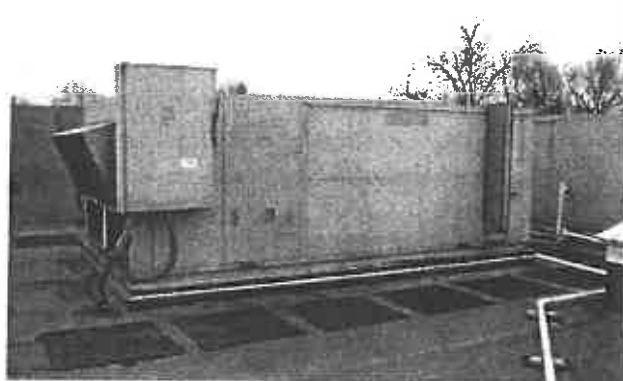
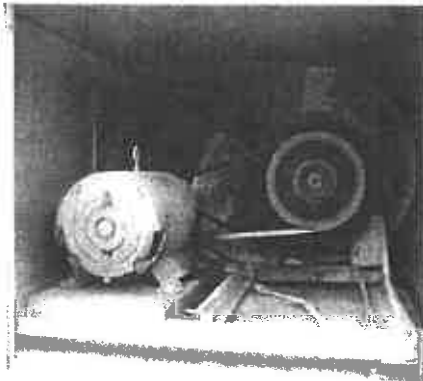
**HVAC-1: Location: Roof, Service:** 11,000 cfm gas fired, direct expansion cooled roof top unit serving the first floor. This unit is in poor condition and has experienced operational issues, including compressor failure. The compressor was recently replaced due to failure.

Typical HVAC-1,2,3 Unit

**HVAC-2: Location: Roof:** 9,400 cfm gas fired, direct expansion cooled roof top unit serving the first floor. This unit is in poor condition and has experienced operational issues.

**HVAC-3: Location: Roof:** 7,800 cfm gas fired, direct expansion cooled roof top unit serving the Lower Level. This unit is in poor condition and has experienced operational issues.

The existing roof top units at the library are in poor condition and should be replaced as soon as funding is available. As a part of this project, the systems should be evaluated in detail to eliminate many of the operational issues experienced in the building as well as raising the unit curbs. The new units should be designed to provide the proper amounts of outdoor air. In addition, we believe the following upgrades to the airside systems will provide improved efficiency and reliability for the library:

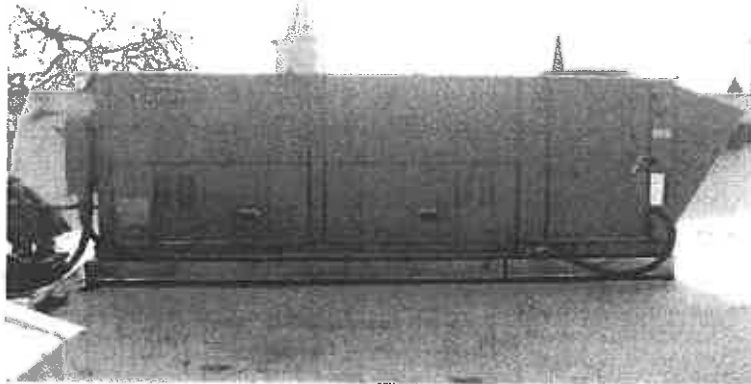
HVAC-4

**HVAC-4: Location: Roof:** 8,000 cfm, gas fired, direct expansion cooling roof top unit serving the Lower Level. This unit is in average to poor condition.

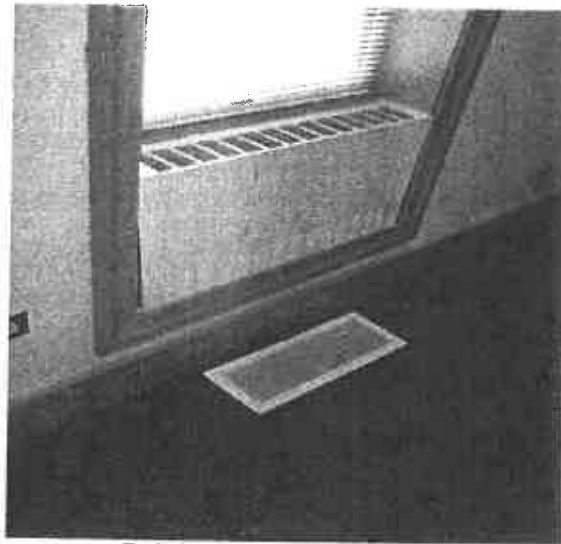
- Perimeter HVAC Arrangement: The perimeter HVAC zones have fin tube at each window location (controlled locally by sensing element) and a floor grille from the zone terminal air box (controlled from the thermostat). These devices likely "fight" each other consistently in an attempt to control space temperature because the devices are not controlled through the same control device, resulting in substantial wasted energy. In addition, we believe that the terminal air box minimums have been reset to 0% (from the design of 30%) which could reduce ventilation levels below code minimums during heating mode.

Typical perimeter HVAC arrangement

- Duct Sealing and Improvements to Distribution: This project would take steps to correct the existing ductwork deficiencies and sealant issues that persist throughout the systems.
- Upgrade of Perimeter HVAC: This project would replace the terminal air box controls and thermostats as well as remove the existing "Danfoss" valves and install control valves throughout the system.

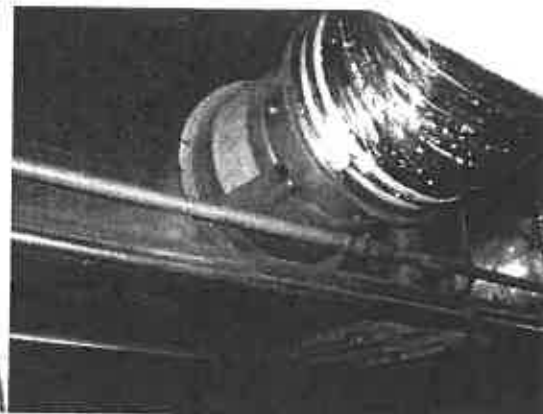
- Duct Construction and Distribution:** During our field survey, many instances of duct air leakage from the roof top unit to the terminal air boxes were observed. This was confirmed by review of the balancing report for the 1990 building addition and conversations with building staff. Many stagnant areas exist in the building and the balancing report shows several areas that achieved less than 50% of design airflow during balancing, which results in discomfort to occupants. The areas with shortages focus on the lower level. This can be attributed to crimped flexible ductwork in many locations and leakage of medium pressure ductwork. Most low pressure ductwork appeared to be sealed. Formal duct static pressure calculations were not performed for the building, but this should be included as a part of any project to correct these issues or replace the roof top units to confirm the pressure drop within the system.

Example location of duct leakage at take-off

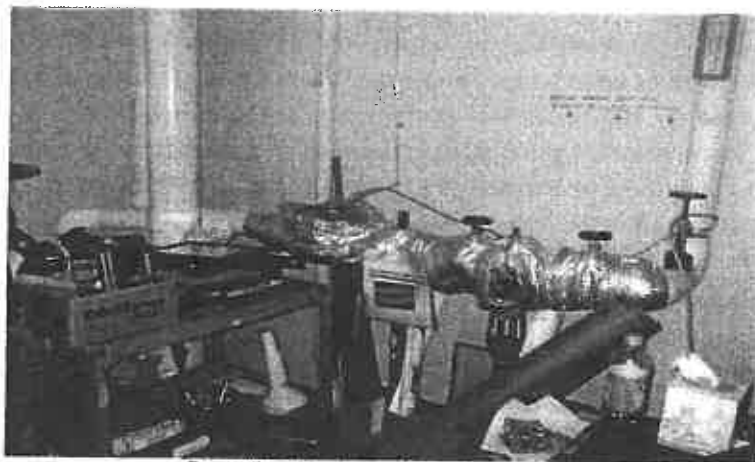
Domestic cold water service meter assembly

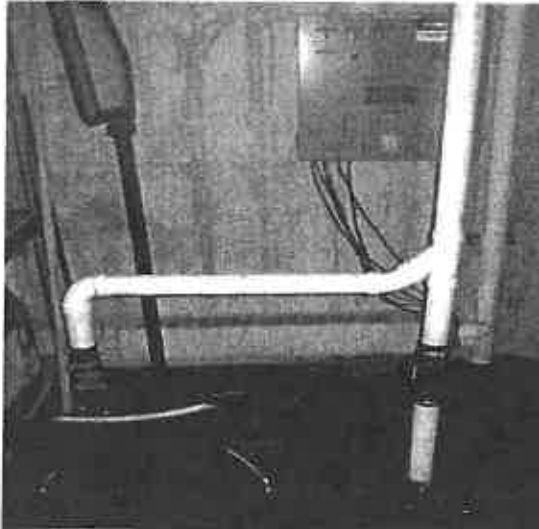
Drain tile sump pump

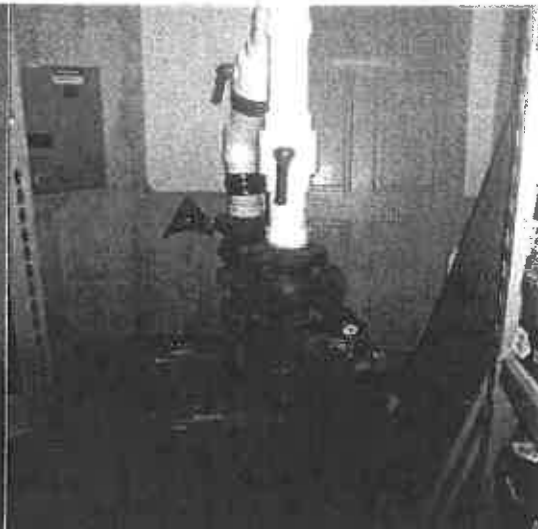
Sump and sewage ejectors are located in the basement. One sewage ejector services all sanitary usages at the lower level including toilet rooms and a break room. The sewage ejector is in good condition and operates reliably according to facility staff. Elevator and drain tile sump pumps are also located at the basement level. All pumps are original to the 1990 addition, and although there are no major related projects for this equipment, engineering staff should monitor the equipment during the upcoming years for repair/replacement under maintenance work.

Building sewage ejector

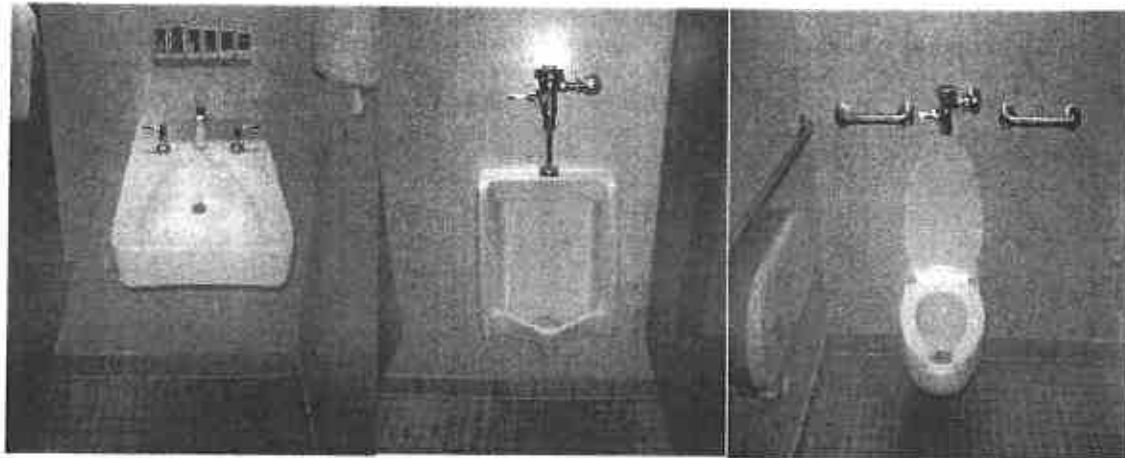
The existing plumbing fixtures in the various toilet rooms throughout the facility appear to be in good condition. Based on conversations with facility staff, maintenance issues on the fixtures are limited, and usually focus on the flush valves. The flow rates associated with the fixtures are as follows:

Representative lavatory, urinal and water closet

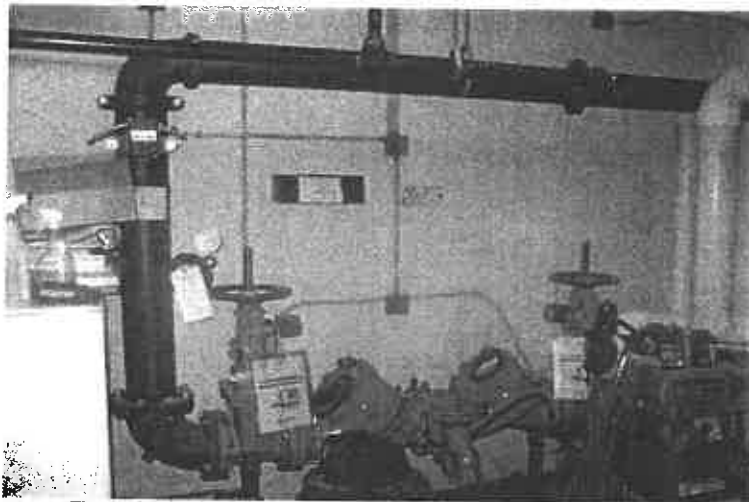
Fire protection backflow preventer with main monitor and flow switches

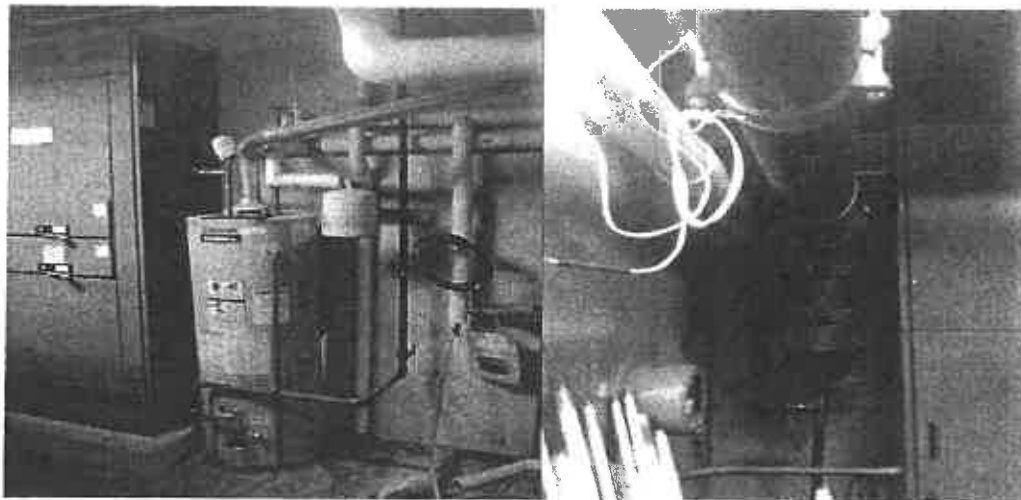
This switchboard is original to the building and appears to be in good condition. However, on the right side of the switchboard is the water heater and on the left side is a sprinkler line. The location of these is not ideal due to the fact that if there is a leak the switchboard will be exposed to water. Also, this room is being used for storage which is not advisable. There has been no maintenance performed on the switchboard.

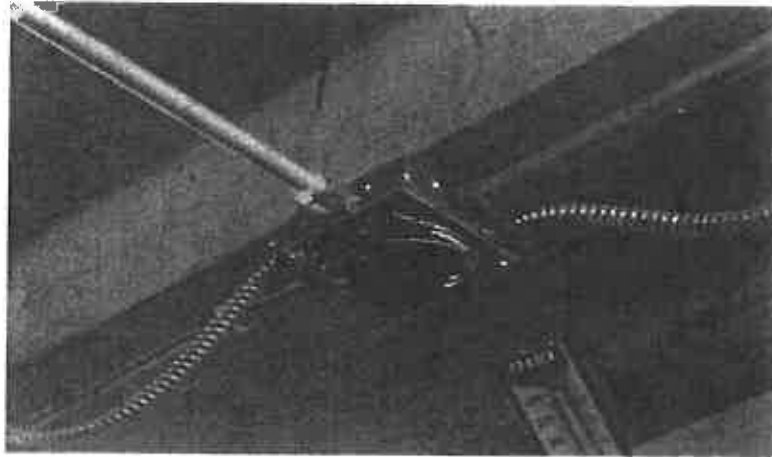
Several open junction boxes with exposed wiring were observed. Having open junction boxes is a code violation and presents possible electrical hazard conditions. The exact number of open junction boxes could not be determined as this would require access above all ceilings.

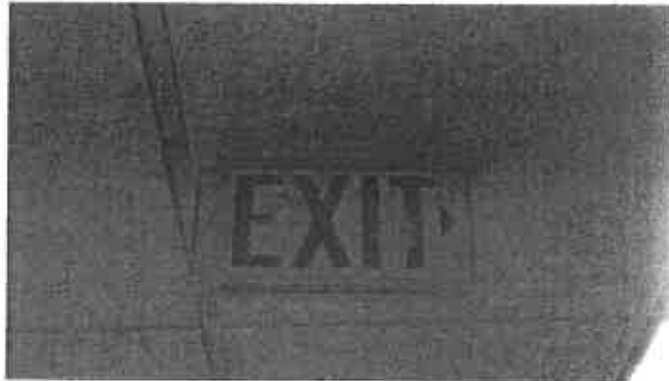
Exit lights are located throughout the library in the path of egress. The existing exit signs are AC power only since they are fed from the generator. They are in poor condition and not energy efficient.

- Replace the existing exit signs which are in poor condition with new LED exit signs which will be more energy efficient.
- Replace the existing exterior building mounted light fixtures that are deteriorating. Consideration should be given to utilizing LED type fixtures.
- Replace the HID interior light fixtures to provide adequate illumination. Consideration should be given to utilizing LED type fixtures.
- Add occupancy sensors in enclosed spaces such as offices, meeting rooms, computer rooms, etc. for automatic shut-off.

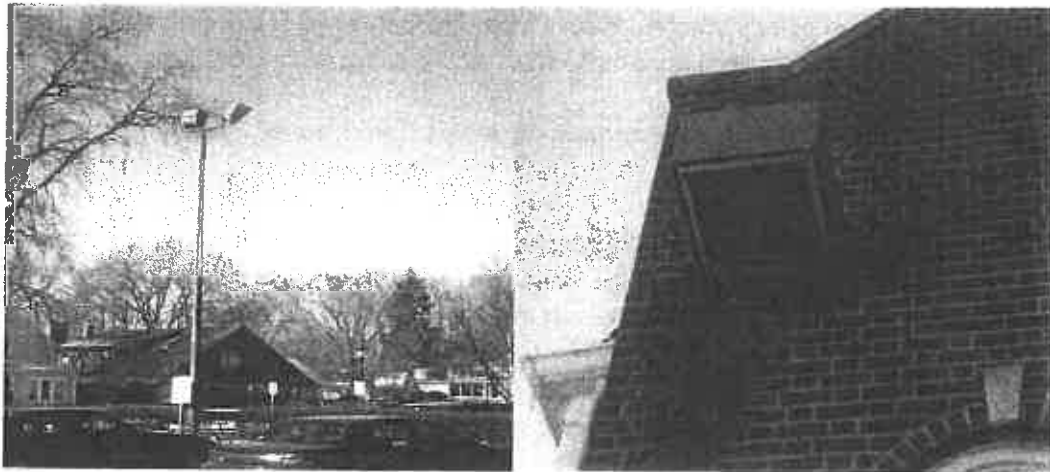
Exterior lighting consists of building mounted lights on the north side and pole mounted light fixtures in the parking lots. All exterior lights are HID type and controlled by a time clock. The building mounted lights indicate some deterioration and rust. Exterior lighting illumination could not be confirmed due to daylight at the time of the survey.

The interior lighting system is in good condition and provides adequate illumination in most areas. The exterior building mounted lights are rusting. The lighting controls consisting of manual switching does not comply with the latest energy codes. We recommend the following:

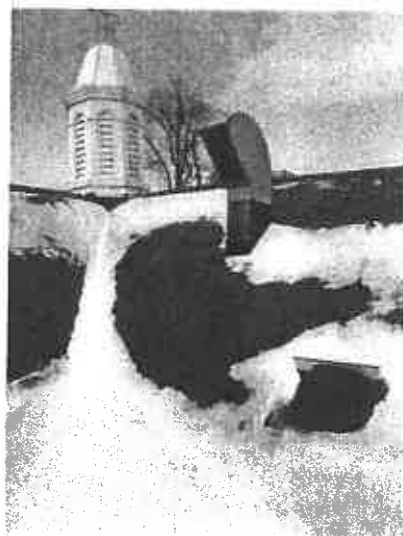
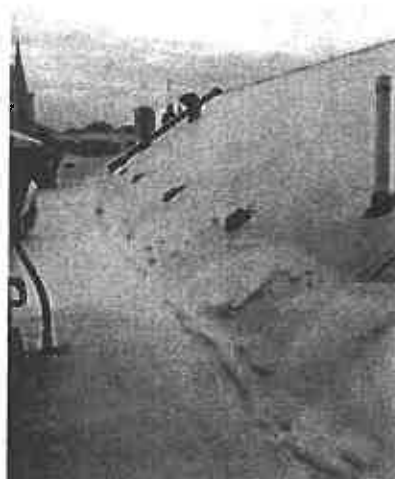
The singled roofs appear original to the construction of the addition with eave and continuous ridge vents. The shingles appear in relatively good condition with localized area of curly. Due to snow coverage, missing aggregate was not noted. One area of leaking with the roof area was reported and corresponds with an area of heavier shingle deterioration. The leaking is most likely due to driving rain, aged shingles, lack of proper shingle overlap or missing felt and water working its way through the joints in the sheathing below the shingles.

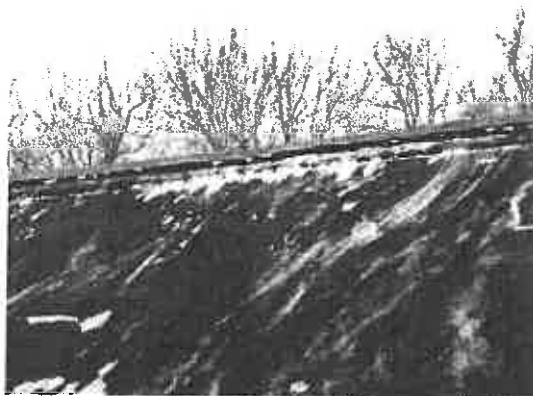
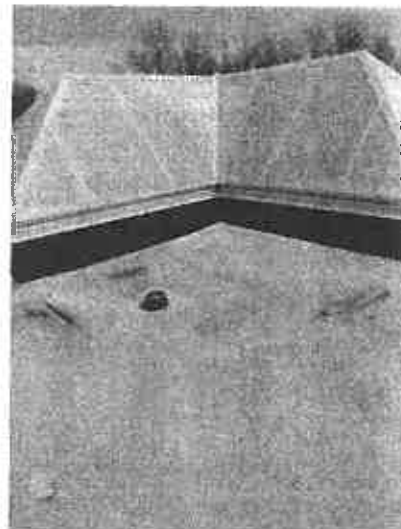
The inner sloped and vertical surfaces of the gabled roofs were reroofed in 2009 when the flat roof was replaced with a single-ply rubber roof system. Rubber roof systems are generally recommended for low-slope roofs but there is no slope limitation to the systems as long as the adhesive is properly applied and cured. Rubber membranes can be mounted to steeply sloped and vertical surfaces and does not require venting. The roof was covered in a light snow during our visit so specific deficiencies in the membrane cannot be identified, however, conditions noted include:

- Wrinkled or pulled membrane on sloped surfaces indicating slippage or other movement in the membrane
- Patching at intersection of sloped roof areas to vertical walls, other sloped areas and flat roof.
- 16 vents are installed at the lower section of the sloped roof area
- Flashing terminations excluding the ridge condition appear to meet minimum industry standards.
- Penetrations at vent stacks, mechanical units and drains appear to comply with industry standards.

With replacement of shingle roofing with single-ply rubber membrane, the manufacturer recommends an 18"-24" extension of the single ply membrane under the shingles thus making the ridge vent inactive. This detail will have short circuited the roof venting and will accelerate the aging of the shingled system and allow heat to build up in the wood members thus contributing to the attic paint failure. Reported leaks at the vent are most likely from driving rain moving water into the ridge vent and following the rubber roof membrane under the shingles, through joints in the sheathing, and into the occupied space. Continuous ridge vent tie-in is a difficult detail and unless installed according to manufacturer's detail, leaking at this condition will continue to be an issue.

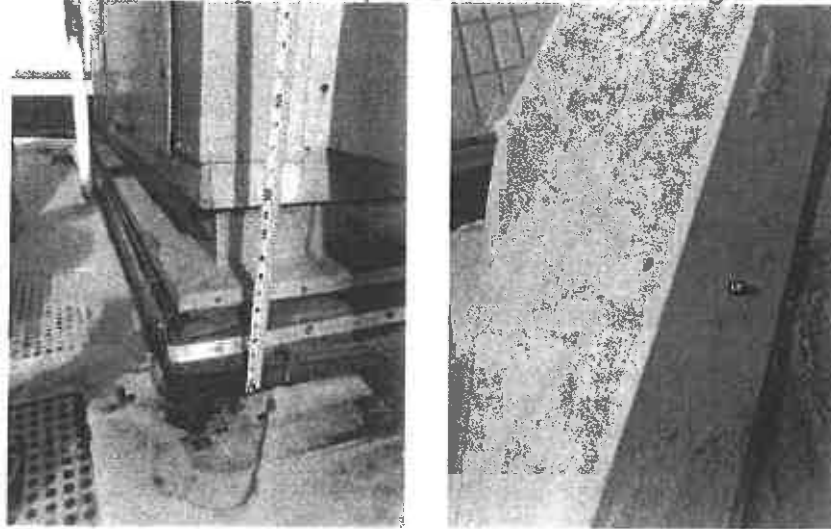
There are four roof drains set in sumps but the clamping ring is set too high and limited water ponds at these areas. There are no crickets around the four large mechanical units creating potential for areas of ponding water.

The roof top mechanical equipment is set on continuous curbs and according to the construction documents, these curbs are vibration isolators, no complaints were reported related to mechanical unit noise beyond air flow. The flashing terminations at the curbs range from 7" to 10" with only 2" clear between the roof membrane and the bottom of the counterflashing. Industry standard recommended a minimum of 8" clear between the bottom of counterflashing and the roof membrane which requires a minimum 12" curb height.

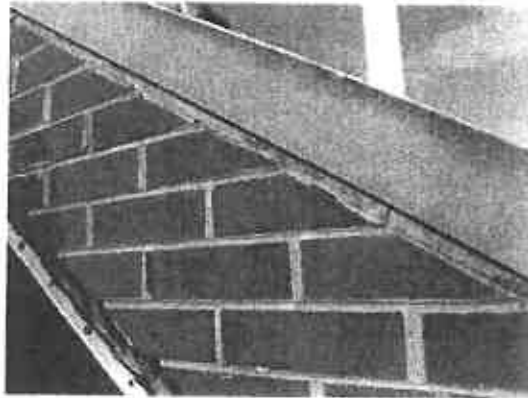
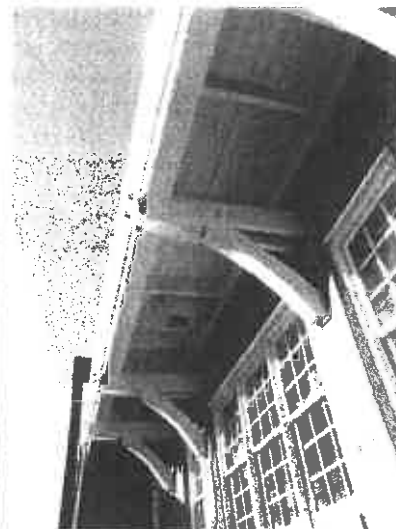
The skylight is identified on the construction documents as a Kalwall system. The system appears in good condition however the aluminum trim is mounted with surface fasteners which are rusting. The fasteners appear to be galvanized steel and were originally separated from the aluminum trim to prevent a galvanic reaction but those washers have deteriorated.

Stone coping up-facing joints at the gable end are reportedly sealed and in good condition as they were not visible due to snow coverage. However, the bed joint below the coping stone is cracked and failing.

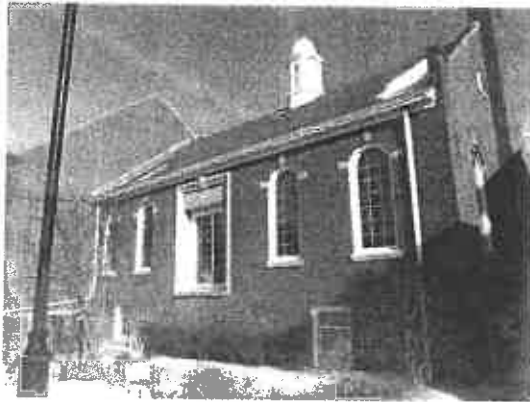
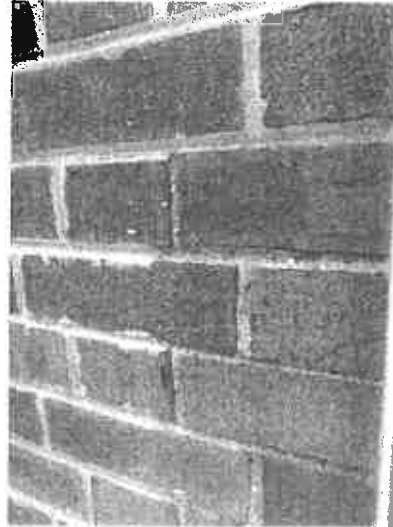
the stairs were removed has been infilled with matching brick. The limestone surround has open and failed joints. The arched window heads are in good condition. The basement window steel lintels are rusting and creating limited vertical cracking in the brick above. Area adjacent to the chimney on the east elevation has open and failed joints where the flush pointing has eroded. It is difficult to determine if all the walls were flush pointed or only areas as the joints are deeply struck. The gable ends show excessive water run off from the change in the coping slope resulting in biological growth (discoloration) on the face of the masonry and joint erosion. Regardless, the pointing craftsmanship is poor in areas as mortar is smeared onto the face of the brick.

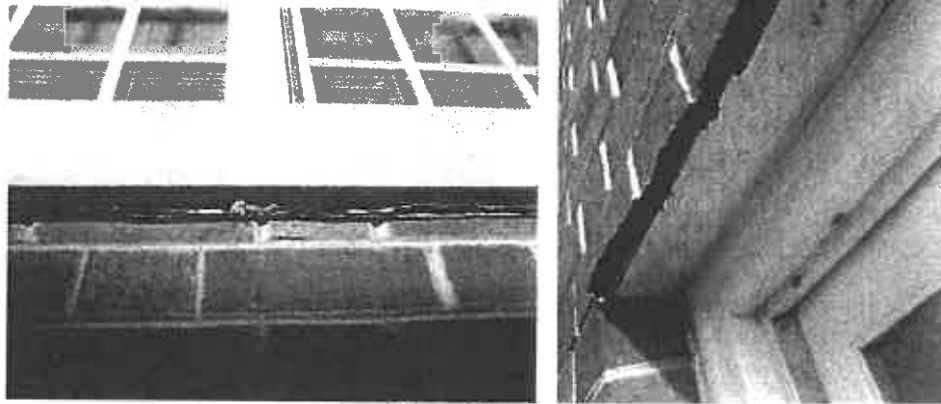
The brick and concrete masonry unit cavity walls are in good condition. No masonry deterioration, displacement or cracking was noted. The window openings are created by a steel lintel and in accordance with the construction drawings flashing and weeps are installed at the head and sill. However, the fabric flashing is exposed to beyond the face of the brick and has become brittle and delaminated. The flashing no longer expels water from the wall. As such the steel lintels are receiving more exposure to water than they should and are developing surface rust. At this point, the rusting is only causing failure to the paint system however, continued exposed will result in rust-jacking, cracking of the brick and water infiltration.

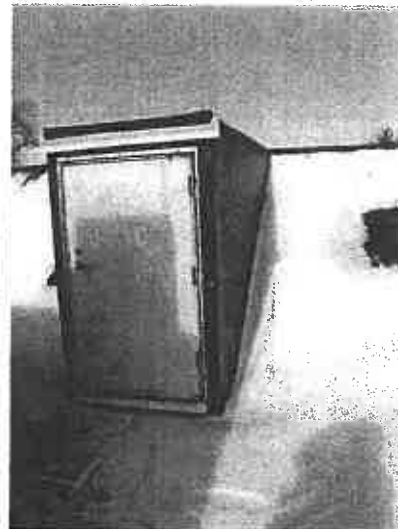
The paired main entrance doors are aluminum and glass and reportedly have locking hardware issues. This could be due to the floor strikes being open and unprotected by a cover thus gathering debris and preventing the vertical rod from engaging. The doors are equipped with a commercial grade Stanley power door operated to meet ADA. These units will burnout over time depending on the frequency of use and the wind pressure they must overcome.

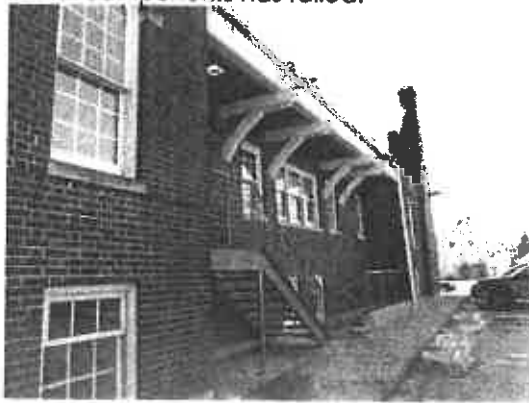
The staff entrance is accessed by a steel pan stair with pipe rails with 9 risers. The basement is accessed by concrete stairs with a pipe rail. The paint system on all metal components has failed.

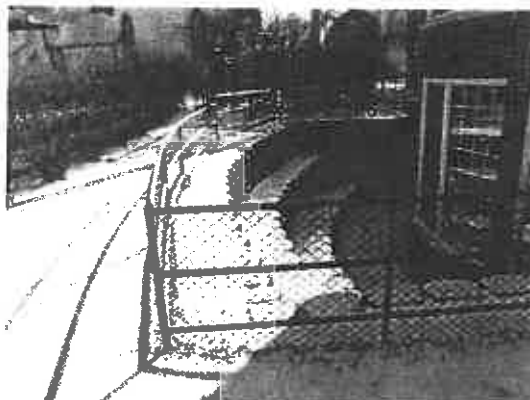
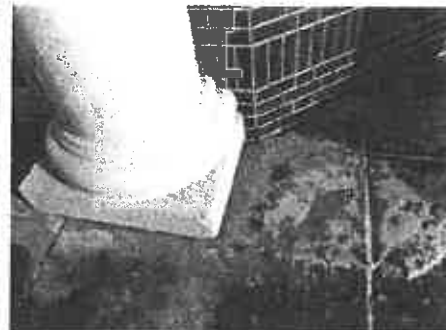
1. Settlement at the main entrance creating cracking in the pavement.
2. Grade appears to slope toward the north area well directly some surface water toward the building.
3. Reportedly there are deficiencies in the parking lot where utilities were previously replaced, the area repaved is failing.

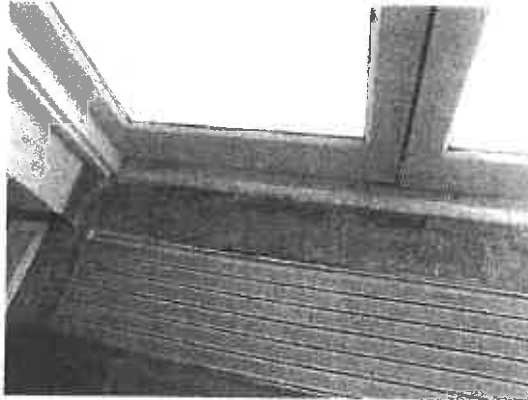
1. Terrazzo cracking at the main entrance. Some cracking at the threshold is related to the site settlement issue discussed above, the other is due to

2. Carpeting is old and stained.
