Strategic Plan

FY2016 and Beyond

Facility Assessment
for Plainfield Public Library
KJWW #11.0712.00
February 9, 2012
Page 15 of 21

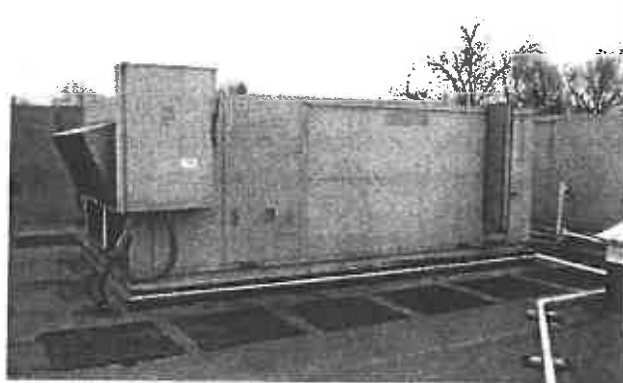
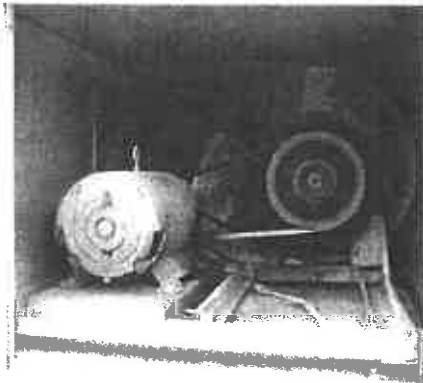
Typical HVAC-1,2,3 Unit

HVAC-1: Location: Roof, Service: 11,000 cfm gas fired, direct expansion cooled roof top unit serving the first floor. This unit is in poor condition and has experienced operational issues, including compressor failure. The compressor was recently replaced due to failure.

HVAC-2: Location: Roof: 9,400 cfm gas fired, direct expansion cooled roof top unit serving the first floor. This unit is in poor condition and has experienced operational issues.

- Estimated Cost: \$50,000
- **Air Handling Systems Replacement & Control Upgrade:** Replacement of central building air handling units and controls.
 - Estimated Cost: \$200,000 – \$250,000

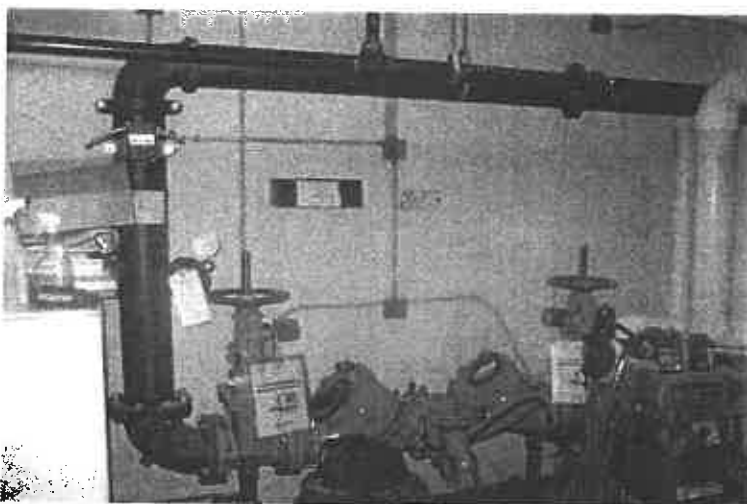
The library is a fully sprinkled building. A 6" fire protection feed originates from the combined incoming water service and serves the entire building after passing through a backflow preventer. Flow and monitor switches for fire alarm annunciation exist on the main fire protection feed downstream of the backflow preventer in the basement, however, no other zones exist in the building due to its size. The attic spaces within the pitched roof portions of the building are composed of combustible construction and are sprinkled with wet sprinklers as the attic insulation is at the roof. No standpipes are present in the building, nor are they required. No dry or other special fire protection systems were observed within the library.

Fire protection backflow preventer with main monitor and flow switches

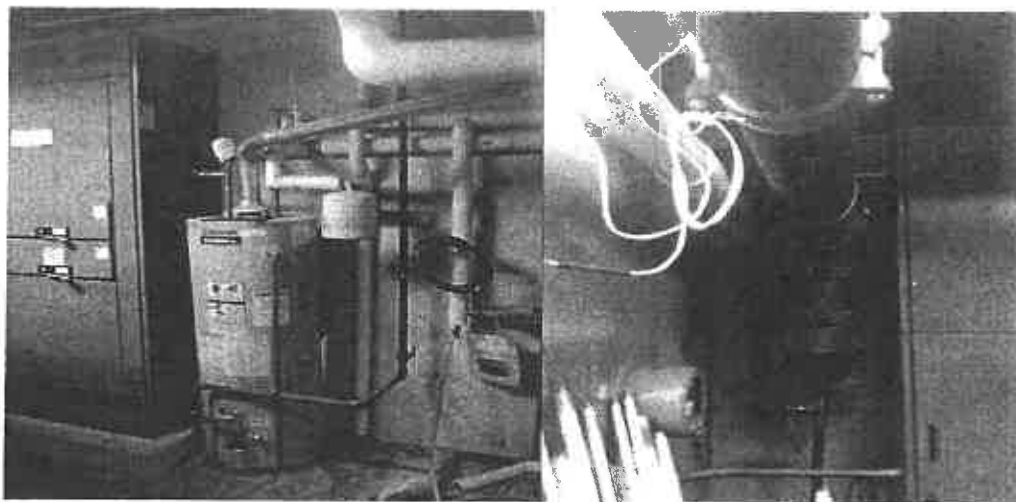
This switchboard is original to the building and appears to be in good condition. However, on the right side of the switchboard is the water heater and on the left side is a sprinkler line. The location of these is not ideal due to the fact that if there is a leak the switchboard will be exposed to water. Also, this room is being used for storage which is not advisable. There has been no maintenance performed on the switchboard.

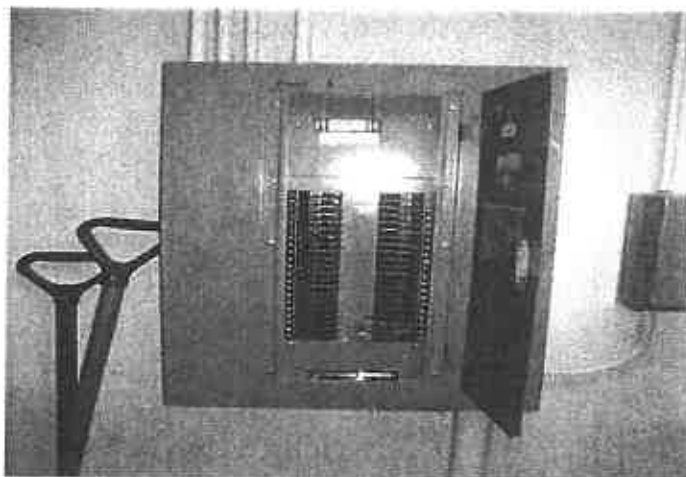
These panels are original to the building and appear to be in good condition. However, the panel board labels and directories on each panel are inadequate and do not reflect accurately the branch circuits served. There has been no maintenance performed on the panelboards.

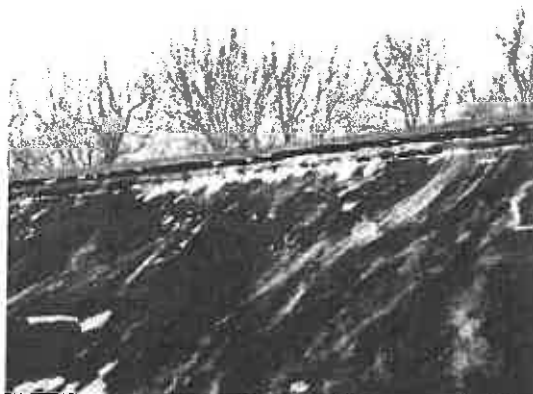
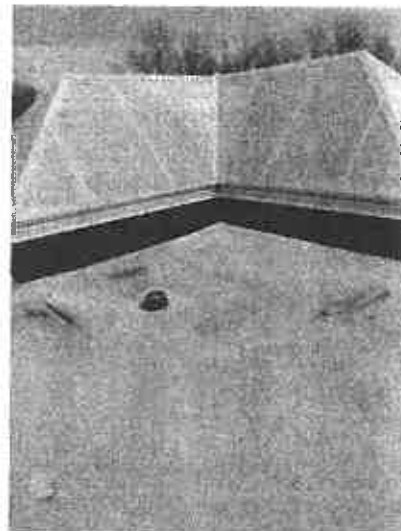
With replacement of shingle roofing with single-ply rubber membrane, the manufacturer recommends an 18"-24" extension of the single ply membrane under the shingles thus making the ridge vent inactive. This detail will have short circuited the roof venting and will accelerate the aging of the shingled system and allow heat to build up in the wood members thus contributing to the attic paint failure. Reported leaks at the vent are most likely from driving rain moving water into the ridge vent and following the rubber roof membrane under the shingles, through joints in the sheathing, and into the occupied space. Continuous ridge vent tie-in is a difficult detail and unless installed according to manufacturer's detail, leaking at this condition will continue to be an issue.

- **Stabilize envelope and address issues that are contributing to ongoing deterioration:**
 - Roof: replace damaged/deteriorated shingles and rubber roofing, reinstate ridge vent operation, tuckpoint copings, coat rubber roof, repair skylight and cupolas, replace curbs and crickets.

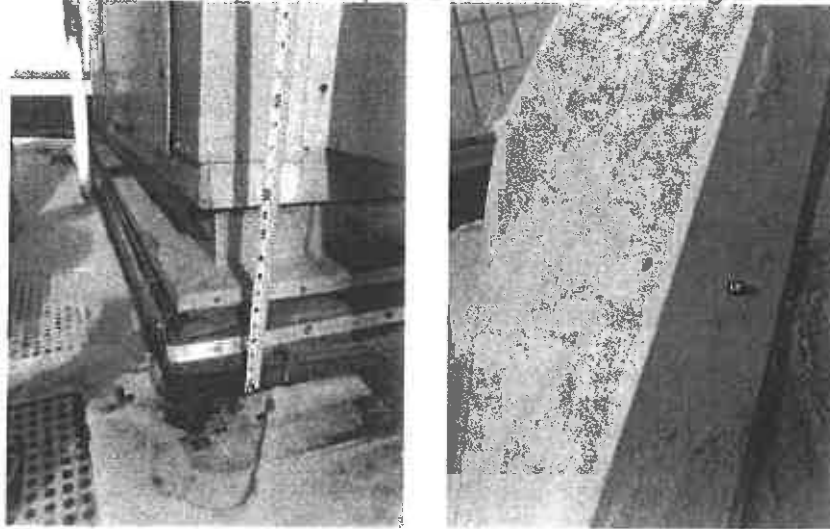
There are four roof drains set in sumps but the clamping ring is set too high and limited water ponds at these areas. There are no crickets around the four large mechanical units creating potential for areas of ponding water.

The roof top mechanical equipment is set on continuous curbs and according to the construction documents, these curbs are vibration isolators, no complaints were reported related to mechanical unit noise beyond air flow. The flashing terminations at the curbs range from 7" to 10" with only 2" clear between the roof membrane and the bottom of the counterflashing. Industry standard recommended a minimum of 8" clear between the bottom of counterflashing and the roof membrane which requires a minimum 12" curb height.

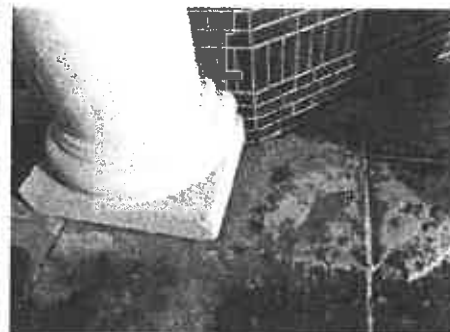
1. Settlement at the main entrance creating cracking in the pavement.
2. Grade appears to slope toward the north area well directly some surface water toward the building.
3. Reportedly there are deficiencies in the parking lot where utilities were previously replaced, the area repaved is failing.

- Site: scrape and paint exterior steel stair assemblies, regrade at north to redirect surface water, repair parking lot.
 - Estimated Cost \$235,000
- **Thermal Scan Switchboard and Panelboards.**
