Facility Assessment and Planning Report

Plainfield Public Library

15025 S. Illinois Street

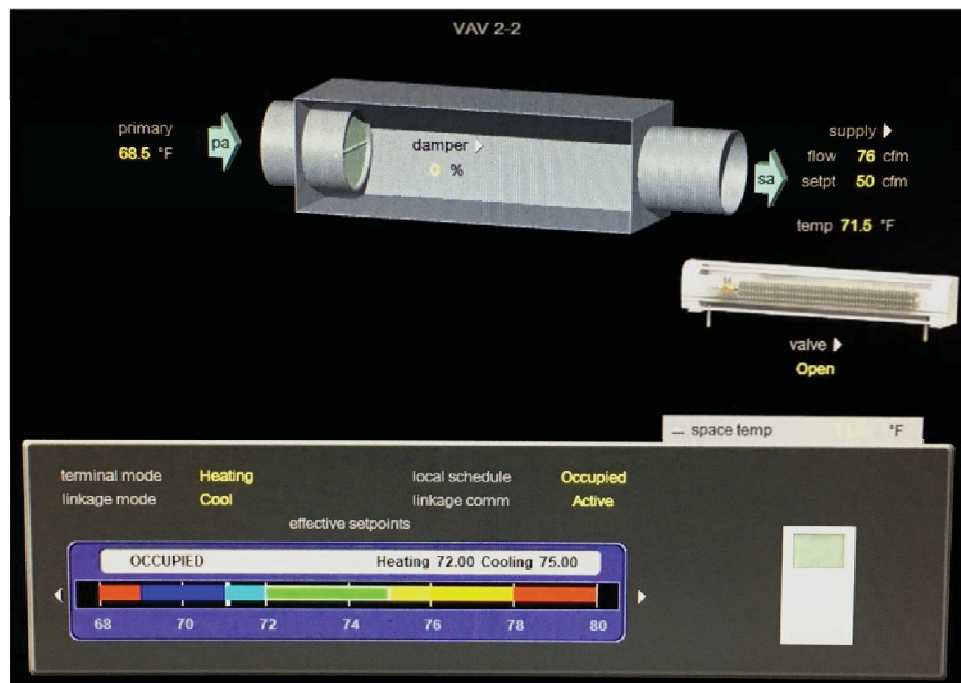
Figure 8: VAV 2-2 with Low Airflow Setpoint, Damper Position of 0%

- b. Suggested Action: It is recommended to adjust the maximum and minimum airflow setpoints for each VAV box to match the design setpoints and/or the ones listed in the test and balance report from 2012. Further investigation is required to ensure the minimum damper position for each box is 30% and the correct programming is in place to limit the dampers going below the minimum position.

- c. Budget Pricing:
 - i. Cost of corrective action with controls contractor - \$750* (est.)

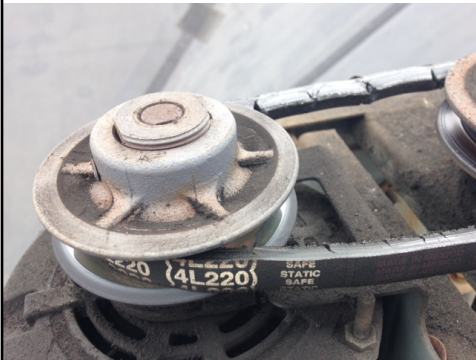
Issue ID:	0004	Status:	Open	Issue Priority:	
Equipment:	EXF-1			Created Date:	27-Mar-17
				Completed Date:	
Issue Description: Belt cracked (4L220) and pulley in poor shape.					
Issue Type: Observation					
Role Assignment: Administrator					
User Assignment: Ron Gordon					
Issue Photos:

Name: Bathroom Exhaust Belt and Sheave.JPG					
Captured: 4/18/2017 1:01 PM					
Caption:

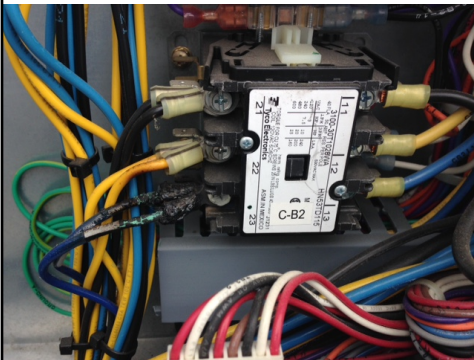
- a. Description: During the visual inspection of RTU-1, the L3 wire for compressor #4 (B2) was found to be burned. The compressor remained disabled during functional testing, and the breaker feeding compressor #3 and #4 was shut off. If enabled, the charred contactor could pose as a fire hazard.
- b. Suggested Action: It is recommended to remove the damaged L3 wire and replace with new electrical wiring and components (if necessary).
- c. Budget Pricing:
 - i. New electrical parts and material (assume work completed in-house) - \$750* (est.)

Issue ID:	0007	Status:	Open	Issue Priority:	
Equipment:	RTU-01/Condensing Unit			Created Date: 29-Mar-17	
Completed Date:					
Issue Description: Compressor #4 (B2) has burnt wire on L3. Compressor was not enabled, and the breaker feeding compressors #3 and #4 was shut off.					
Issue Type: Observation					
Role Assignment: Administrator					
User Assignment: Ron Gordon					
Issue Photos:

Name: RTU-1 Burned Contactor for Compressor B2.JPG					
Captured: 4/18/2017 1:06 PM					
Caption:

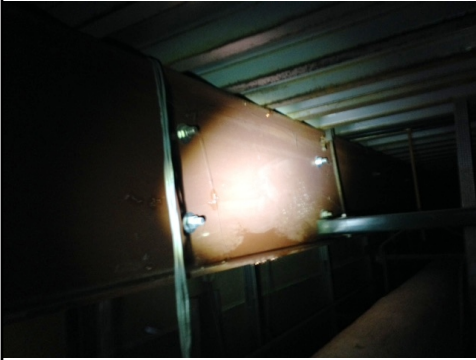
Issue ID:	0022	Status:	Open	Issue Priority:	
Equipment:	RTU-01			Created Date: 30-Mar-17	
Completed Date:					
Issue Description: Water leaking into building by RTU-1. It appears that the water is entering the building 2 feet west of gas pipe penetration (building was shown area on roof).					
Issue Type: Observation					
Role Assignment: Administrator					
User Assignment: Ron Gordon					
Issue Photos:

Name: Roof Deck Leak (Not From Curb).JPG					
Captured: 4/18/2017 1:09 PM					
Caption:

- a. Description: The condition assessment of the plumbing equipment revealed several additional maintenance items that should also be addressed. These include roof deck repair for water leakage near RTU-1, adjusting motion sensor timeouts in all restrooms, repair of hot water valve that cannot be adjusted, and adding covers on the piping under sinks in the women's restrooms. Issues with some restrooms not getting hot water should also be investigated.
- b. Suggested action: It is recommended to address all mechanical maintenance items as can be completed in-house. To ensure the future operation of the equipment, a preventive maintenance plan or contract should be put in place either in-house or from a qualified contractor.
- c. Budget Pricing:
 - i. Correction of existing plumbing maintenance items – TBD

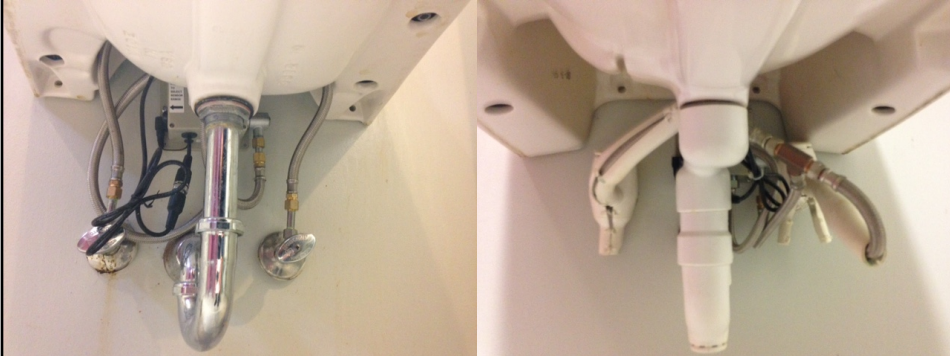
Issue ID:	0029	Status:	Open	Issue Priority:	
Equipment: Project		Created Date: 18-Apr-17			
Completed Date:					
Issue Description: Piping under sinks only covered in men's restrooms.					
Issue Type: Observation					
Role Assignment: Administrator					
User Assignment: Ron Gordon					
Issue Photos:

Name: Sink Without Insulation - Ron.JPG			Name: Sink With Insulation - Ron.JPG		
Captured: 4/18/2017 1:48 PM			Captured: 4/18/2017 1:49 PM		
Caption:			Caption:

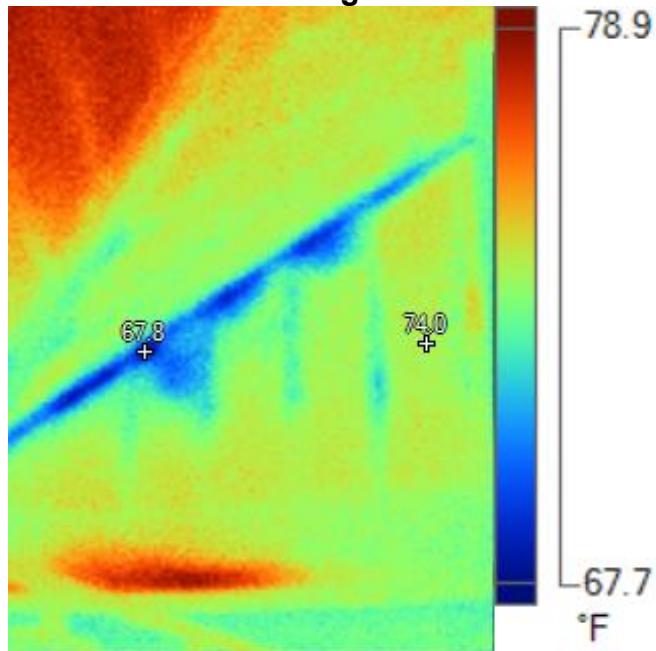
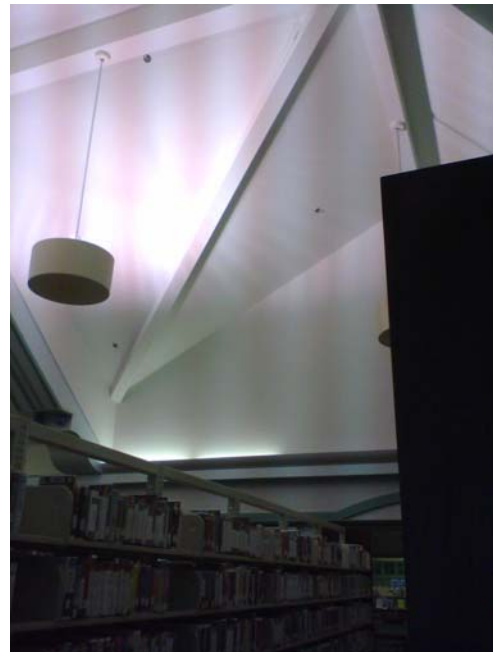
Stairwell Atrium Facing Southwest

The ceiling section appears to have excessive heat loss at the above connection, most likely due to missing insulation. This is not as prominent in the other images for the stairwell atrium ceiling.

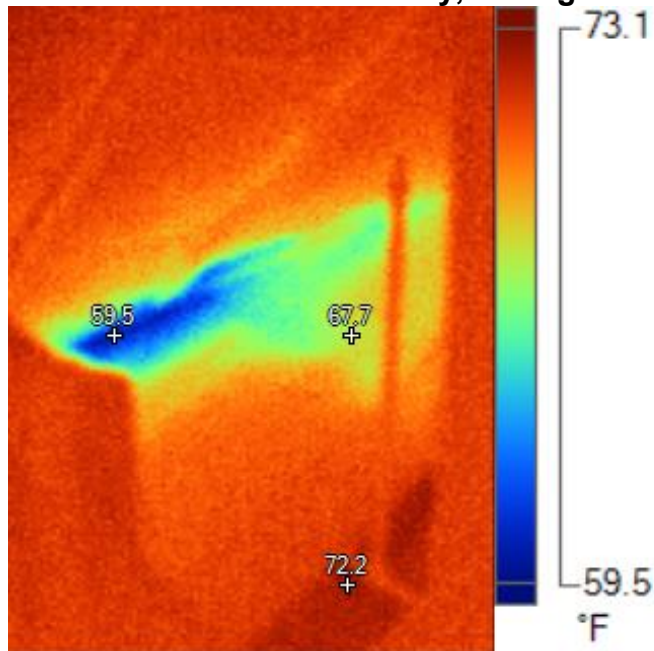
Attic Portion East of Walkway, Facing North

The portion of the wall that extends above the ceiling appears to have excessive, most likely due to missing insulation.
