**Plainfield Public Library**

## **Facility Infrastructure Assessment**

**KJWW#11.0712.00**

**February 9, 2012**

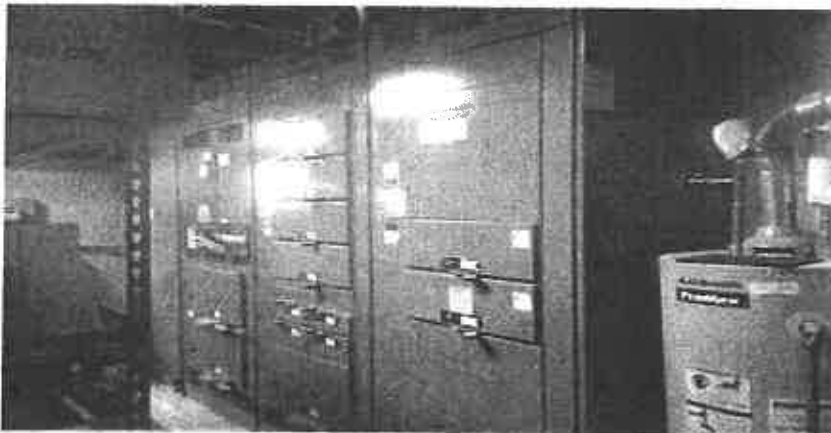
The electrical service comes into the building from the utility transformer and terminates in the main switchboard which is rated at 208/120 volts, 3 phase, 1600 amps. The switchboard is Square D with a 1600 amp CT and 1600 amp main fuse disconnect.

This switchboard is original to the building and appears to be in good condition. However, on the right side of the switchboard is the water heater and on the left side is a sprinkler line. The location of these is not ideal due to the fact that if there is a leak the switchboard will be exposed to water. Also, this room is being used for storage which is not advisable. There has been no maintenance performed on the switchboard.

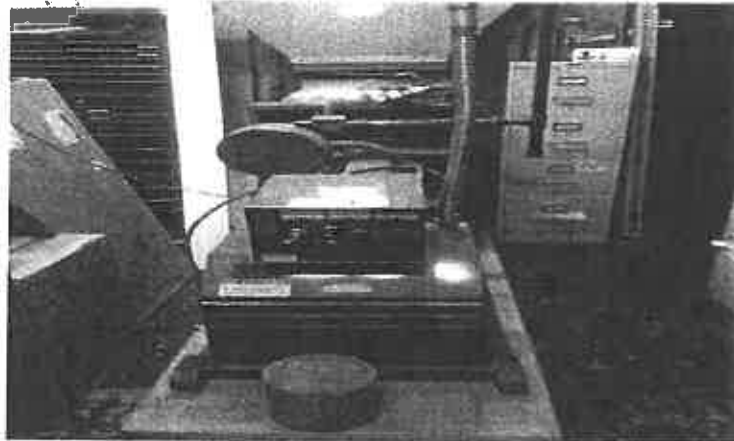
There is an emergency generator (208/120 volts, 3 phase, 69 amp output) located in the basement with an ATS located in the main electrical room. The generator is an Onan 20 kw natural gas generator original to the building. The generator is exercised weekly. The total run time on the generator is approximately 320 hours.

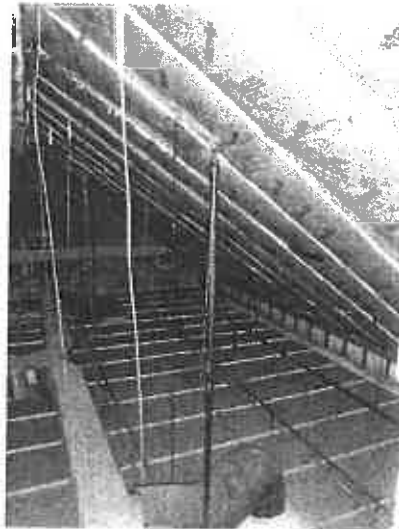
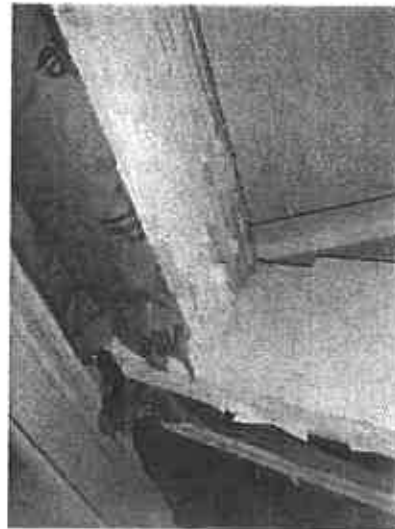
The 1990's roof structure is composed of 2x12 rafters and plywood sheathing covered either by a shingled roof system or a single ply rubber roof. There is limited attic space at the southwest corner of the building. The other gabled roof sections of the addition have cathedral ceilings. The original 1940's section of the building reportedly has its original plaster ceiling with a suspended acoustic tile ceiling system mounted below. In the attic areas, the rafter spaces are packed with paper-faced batt insulation with a 2" air space above. The exposed and concealed wood elements were painted at the time of construction and the paint system is currently peeling. This failure of the paint system is most likely due to age and deterioration from heat build up below the roofing systems and within the

wood elements. According to the construction drawings, the cathedral ceilings are similarly insulated with a 2" air space to allow venting of the roof system. There are limited reported leaks and limited evidence of leaking through the roof system and at intersections of roof areas. Signs of leaks consist of water staining at edges of the batt insulation, edges of acoustic tiles, and discoloration of painted attic elements. There is full walk-up access to the roof.

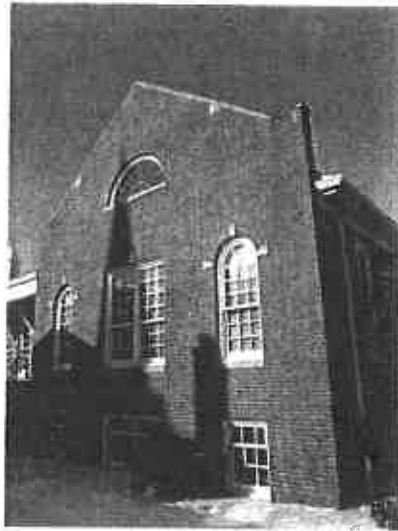
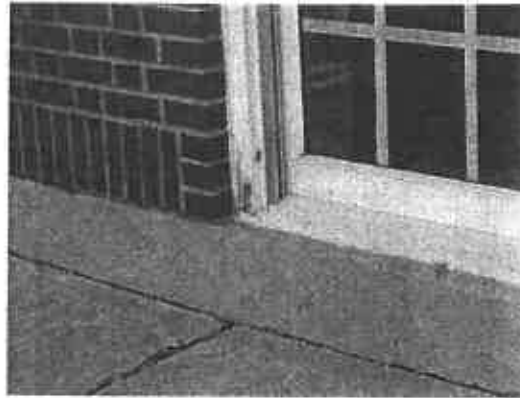
The faceted reading room at the north elevation shows the greatest level of window deterioration and where previous repairs were executed. Window sills are not continuous and provide avenues for water into the wall system.

Several of the windows sills at the northeast section of the building are very close to grade but do not appear to be exhibiting deterioration due to excess water contact.
