Facility Assessment and Planning Report

Plainfield Public Library

15025 S. Illinois Street

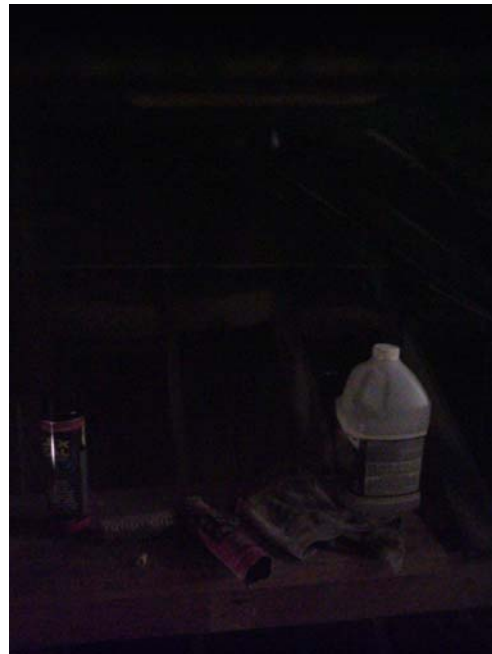
IR004662.IS2

Name	Temperature
P0	73.0°F
P1	72.3°F
P2	65.0°F

Attic Portion East of Walkway, Facing East

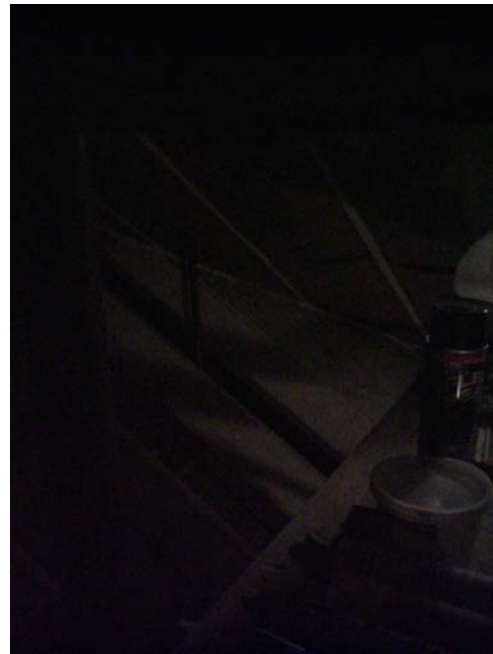
IR004663.IS2

Name	Temperature
P0	63.0°F
P1	69.4°F
P2	73.7°F

Attic Portion of Walkway, Facing South

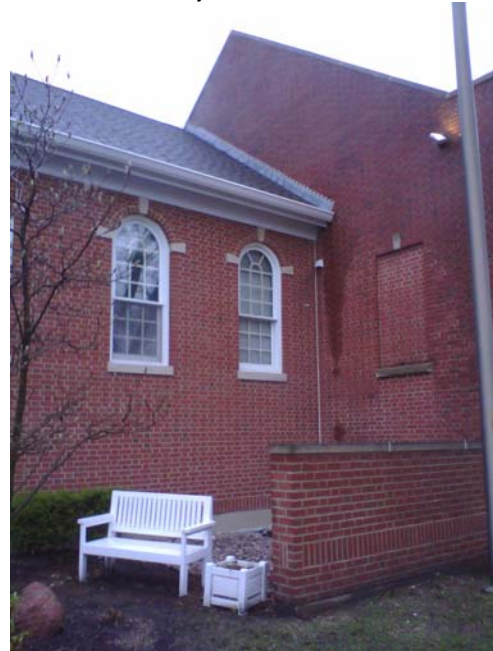
IR004628.IS2
4/5/2017 4:44:37 PM

West Wall, North of Main Entrance (Hot Spot is Exhaust Air)

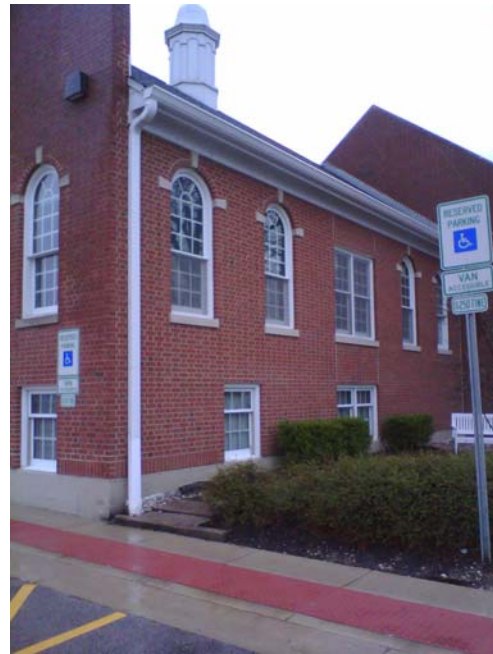
IR004629.IS2
4/5/2017 4:45:09 PM

Name	Temperature
P0	83.4°F
P1	57.3°F
P2	50.7°F

Northwest Corner Facing South

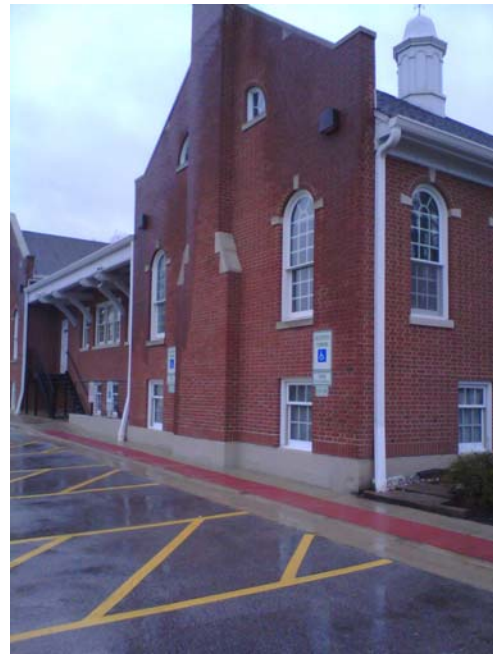
IR004630.IS2
4/5/2017 4:45:40 PM

Name	Temperature
P0	52.0°F
P1	44.4°F
P2	46.8°F

Northwest Corner Facing East

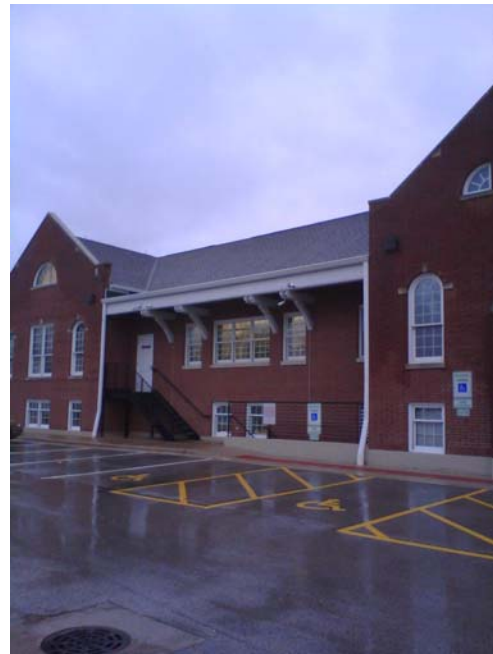
IR004631.IS2
4/5/2017 4:46:02 PM

Name	Temperature
P0	49.6°F
P1	45.1°F
P2	45.3°F

North Wall by Staff Entrance Facing East

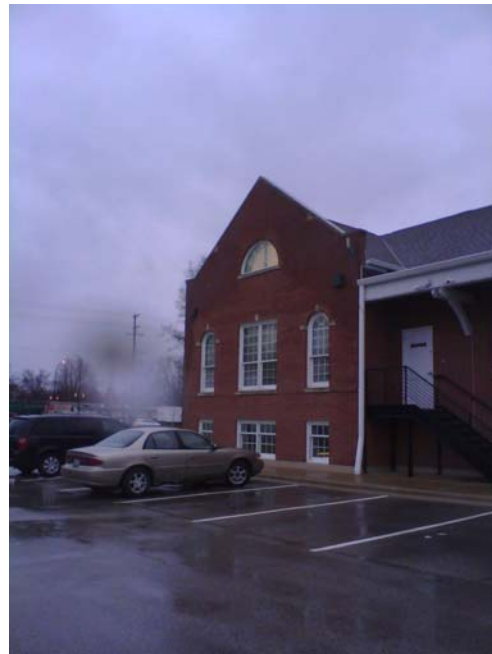
IR004632.IS2
4/5/2017 4:46:15 PM

Name	Temperature
P0	49.1°F
P1	48.4°F
P2	48.3°F

Northeast Corner Facing South

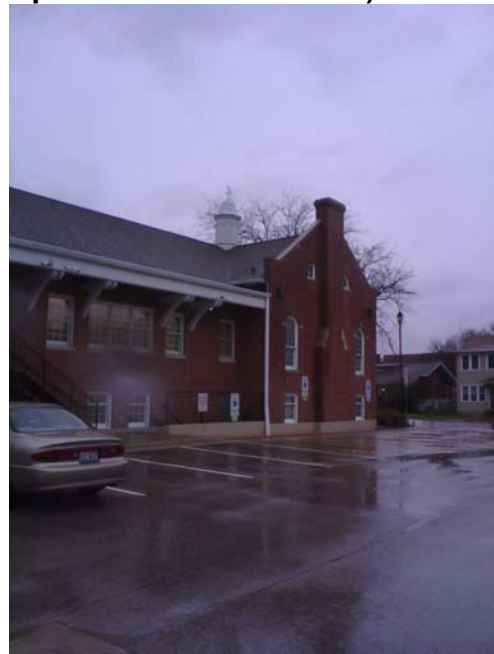
IR004633.IS2
4/5/2017 4:46:38 PM

Name	Temperature
P0	47.0°F
P1	46.5°F
P2	46.3°F

North Wall by Staff Entrance Facing West (Hot Spot is Exhaust Louver)

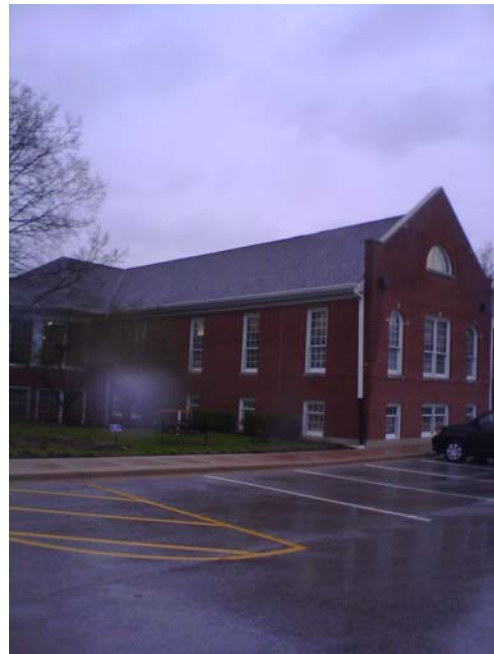
IR004634.IS2
4/5/2017 4:47:10 PM

Name	Temperature
P0	55.0°F
P1	43.4°F
P2	43.1°F

Northeast Corner Facing West

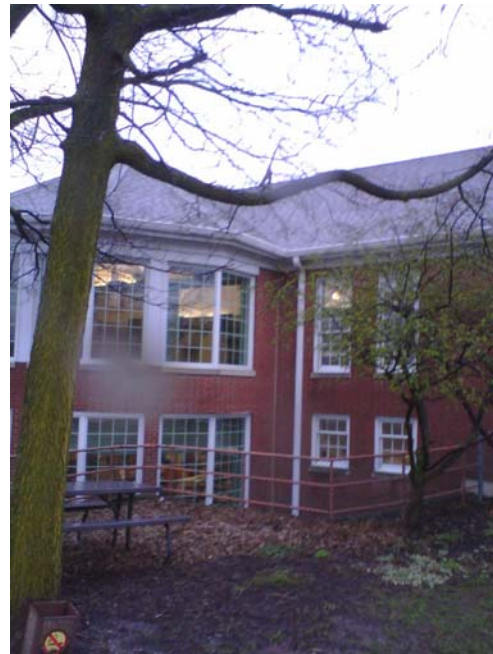
IR004635.IS2
4/5/2017 4:47:36 PM

Name	Temperature
P0	40.7°F
P1	40.2°F
P2	38.2°F

East Wall, North Portion of Arched Section

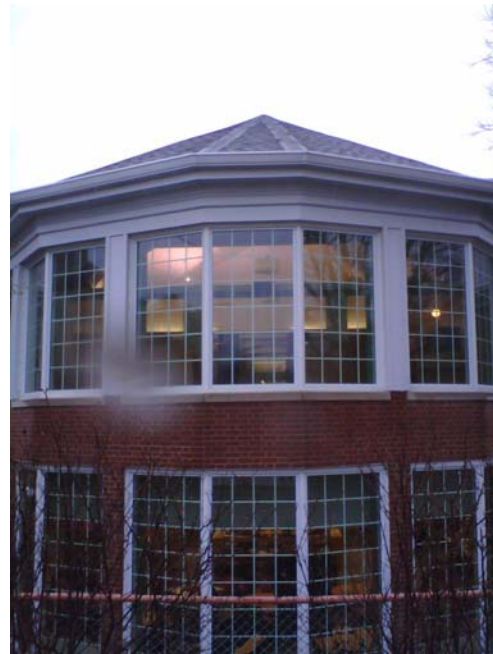
IR004637.IS2
4/5/2017 4:48:13 PM

Name	Temperature
P0	43.4°F
P1	42.6°F
P2	39.5°F

East Wall, Facing Arched Section

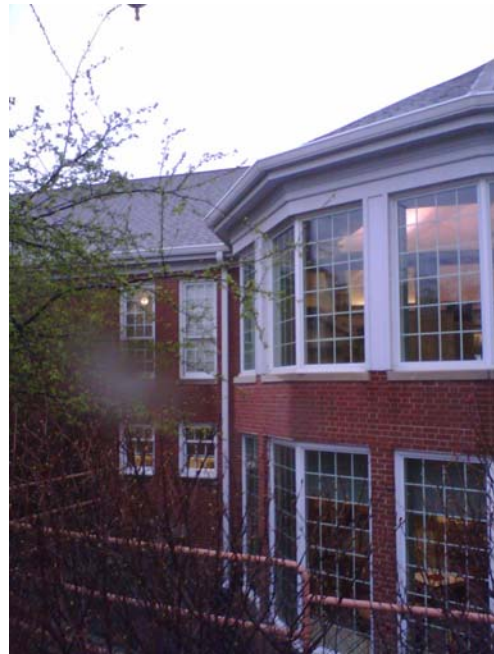
IR004638.IS2
4/5/2017 4:48:26 PM

Name	Temperature
P0	40.9°F
P1	38.2°F
P2	40.2°F

East Wall, South Portion of Arched Section
